GEOTECHNICAL INVESTIGATION ON CAUSES OF ROAD FAILURE OF
DODOLA –GOBA ASPHALT ROAD PROJECT AND THEIR REMEDIAL
MEASURES

JUNE, 2022

A THESIS SUBMITTED TO THE DEPARTMENT OF CIVIL ENGINEERING,
FACULTY OF CIVIL ENGINEERING AND BUILT ENVIRONMENT, SCHOOL OF
GRADUATE STUDIES HAWASSA UNIVERSITY.

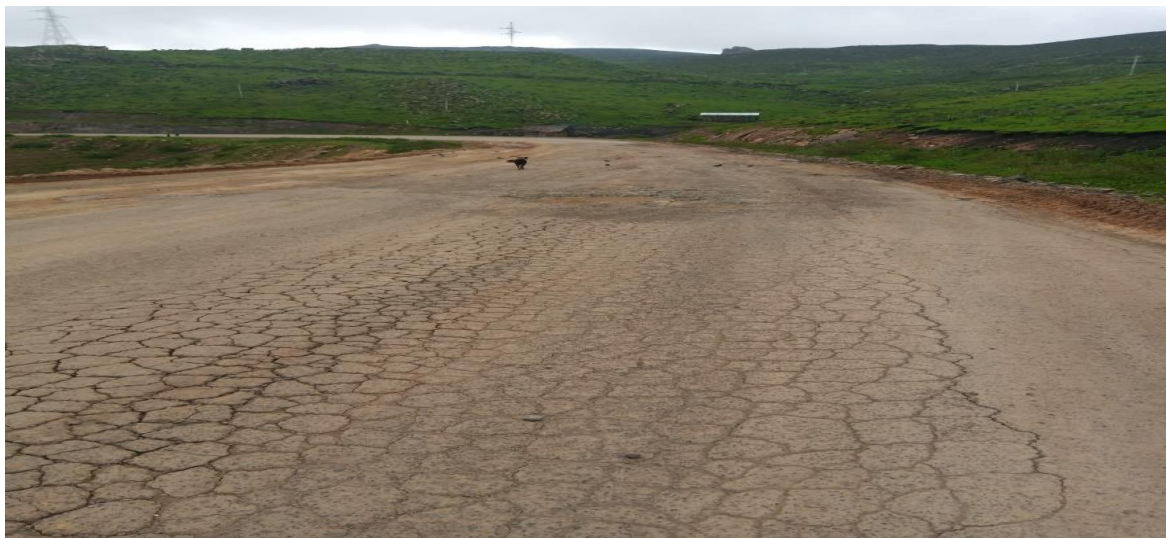
Series of interconnected cracks creating small, irregular shape pieces of pavement results large alligator or fatigue cracks were observed during field inspection as shown in fig 4.1. Alligator cracks indicate a loss of sub grade support and sign of a general pavement structure failure, associated with base or drainage problems as described by KC Sethi (2016). During field inspection, the surface water from rain fall or mountain penetrate with in cracks in to pavement materials and sub grade, causes for other type of failure like potholes. Additionally, wider rutting's failure associated with fatigue cracking are observed on the surface of this sections as shown in fig 4.1 which indicates of mostly subgrade material failure and also some pavement material failure is occur due to heavy traffic load, in adequate compaction and excess moisture as discussed in chapter two.

Figure 4-1 Alligator cracking and rutting failures observed at location around 375+000km

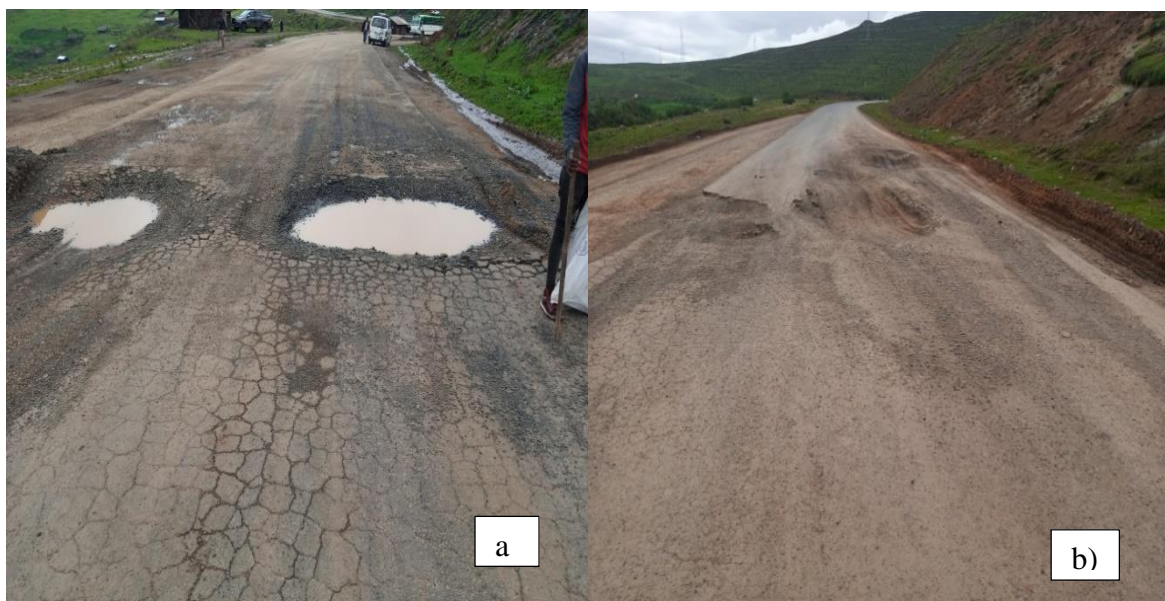
Similarly, potholes are widely observed failure type at this section which results from several alligator cracks due to inadequate strength in one or more layers of the pavement and subgrade, accompanied by the presence of water and drainage problems. During observation water ponds on potholes are common during rainy seasons of this section as shown on fig 4.2a and the water infiltrate in to pavement layers, base, sub base and subgrade material

Figure 4-2 a) Water ponds on potholes failures observed at location around 377+600km.

b) Interconnected potholes and edge failures on the road surface at location around 375+000km.

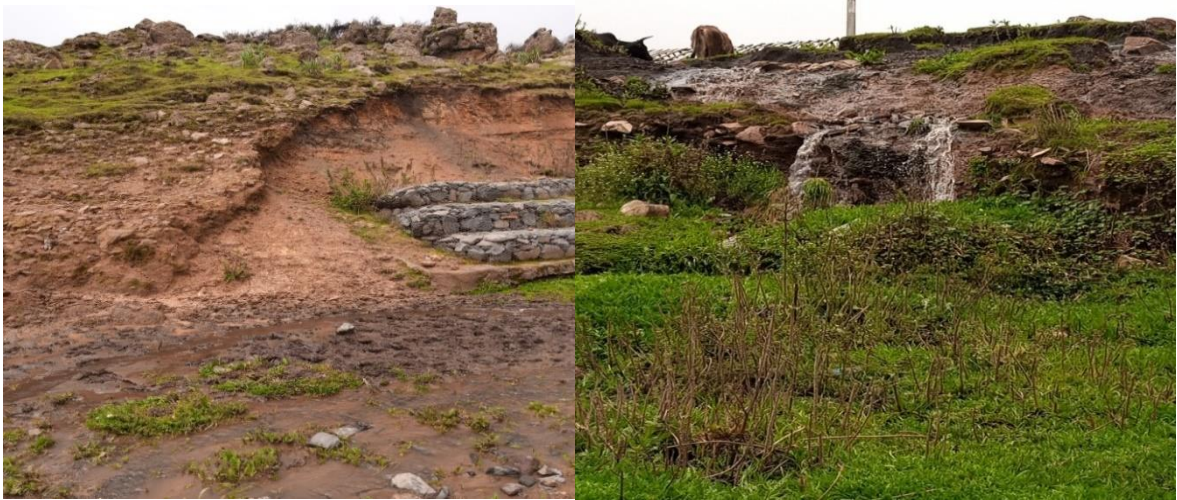
during rainy season intercepts the cut slope causes flood flows through cut face from top hill to toe slope as shown on fig 4.3.

Figure 4-3 Geological profile the road and falling flow of ground water from upper hill at location around 377+000 and 376+000

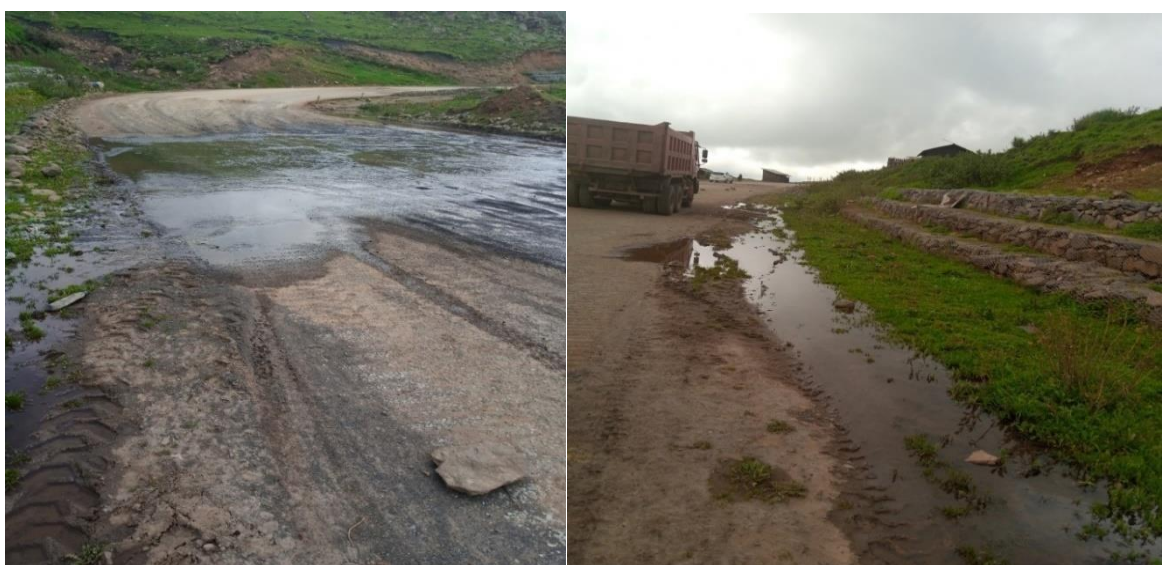
The drainages of this road section were poor and susceptible to saturate sub grade and paving materials. During observation side ditches of this section silts up by eroded or slide soil material from hill cut slope and cannot cache water from cut slope and road surface at toe of each cut section. During sampling of this section, side drains and culverts was silt up by soil and rock material slides from failed slope, that results water fall on the surface of asphalt and shoulder from cut slope and surface drainage. This water infiltrate through the surface, or could flow laterally from the pavement edges and shoulder ditches.

Figure 4-4 Side ditches silts up by eroded or slide soil material from hill cut slope and water falls on the surface of asphalt and shoulder location around 377+000 and 376+000

The moisture entry from the side caused by poorly constructed surface drainage, and lateral movement of water into pavement. Eventually reduces strength and stiffness of pavement materials, being worse for the subgrade material. Improper design and late maintenance of side and cross drainage structures are back onto the road or not keep it from draining away flows on road surface were observed as shown on fig.4.4. Too much water remaining on the surface combine with traffic action are major causes potholes, cracks and other pavement failure of this section.

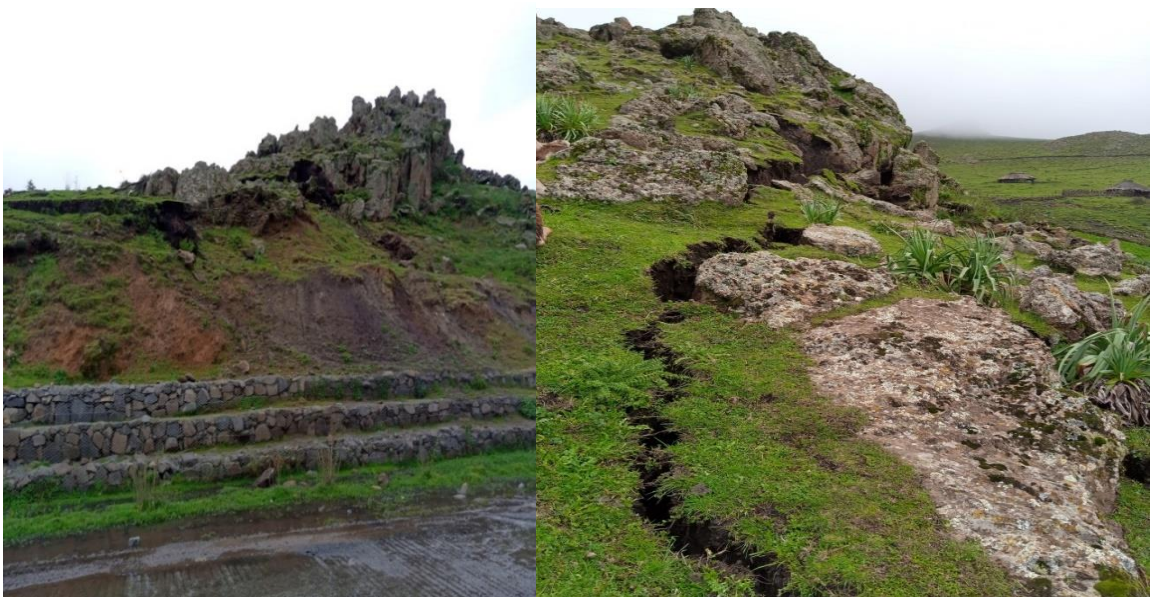
Landslides or slope failures are common on this road sections and triggering from weak geology, topography, climate variation, and effect of ground water as shown on fig 4.5. Weak geology or weak soils overlying harder rocks provide an interface or potential shear surface along which landslides can initiate. Topographical or steep hillsides promote gravity induced slope failures and concave slope facets which can hold moisture for long periods of time, this leads to lower effective stress and reduced strength. Groundwater increases the weight on a slope there by increasing the total stress or driving force and also clays are hydrate and expand and make them susceptible to failure.

Figure 4-5 Land slide occurs during sampling location around 376+800km

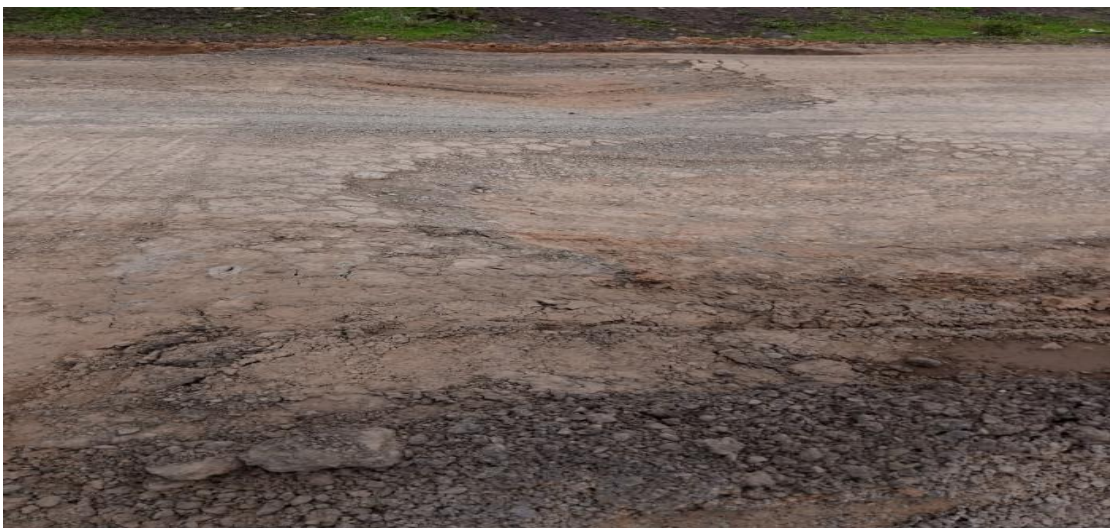
Currently the most stations of this road section are failed beyond critical state and repetitive maintenances were done on these stations by ERA regional shashemene district office. Patches and rigid concrete pavement overlaying rehabilitations types were done for failed stations. Patches repair were done on potholes, but after few months later the surface became fail again. This indicate that patches cannot proper maintenance methods potholes failures and the cause failure are structural problems induced from subgrade and pavement materials (base and sub base) rather than surface layers. Applying the wrong remedial treatment could be a waste of time and money. Concrete pavement over laying rehabilitations up to 20meter length with 7meter width were done on rutting, cracking and pothole failures of this road sections. Rehabilitations made by concrete pavement overlaying methods have good performance, but suddenly alligator cracks and potholes failures were initiated between flexible pavement and rigid concrete slab due to non-uniform transition of materials and piping were seen during observation. Concrete overlaying slabs cannot proper maintenance methods due to uneconomical solution using on all failed sections.

Figure 4-6 Sudden progresses of alligator cracking and potholes at transition of flexible pavement and rigid concrete slab 375+800km

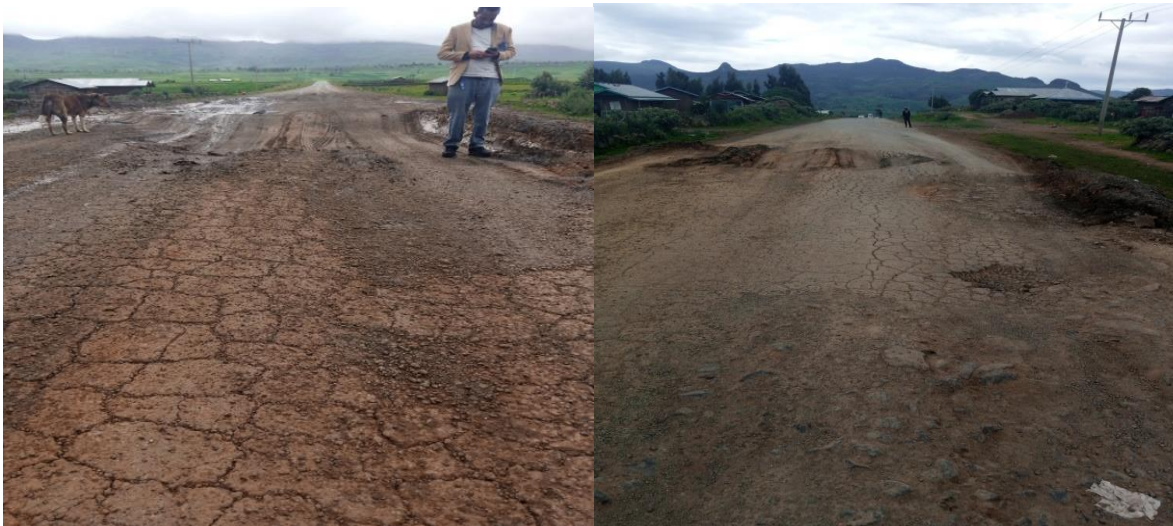
The area of this section has flat and swampy and may not drain fast when high amount of precipitation conceded. The geology of this section was majorly covered by residual block cotton clay soil which generated from highly weathered basic basalt rocks.

Figure 4-7 Alligator cracking, potholes and rutting type road failure at station 386+800 and station 388+300.

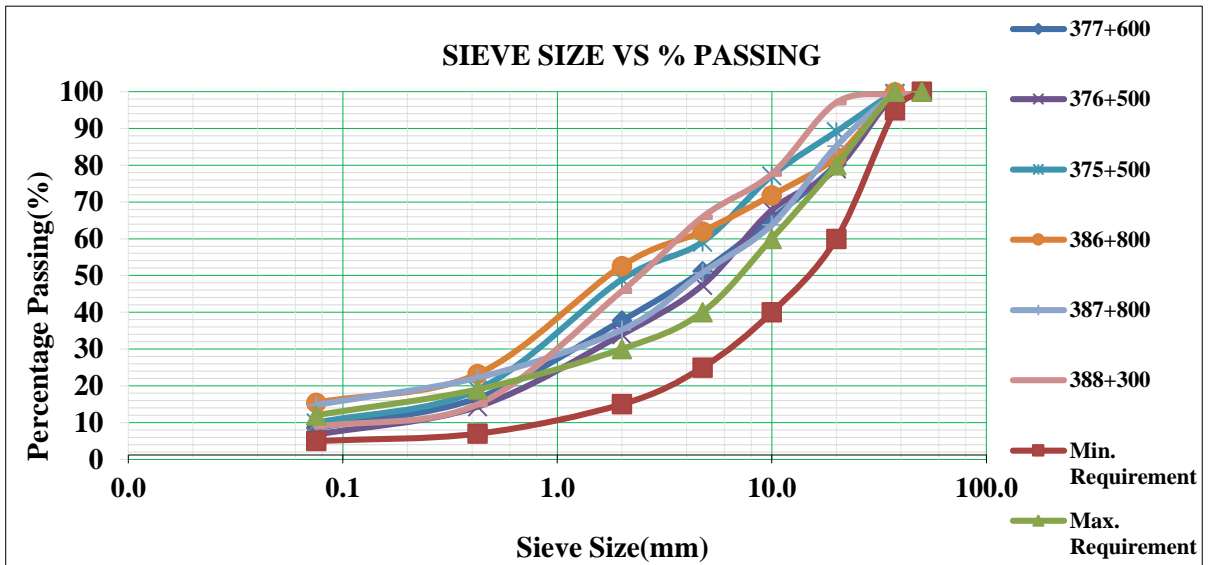
Figure 4-9 Sieve analyses results of base course material

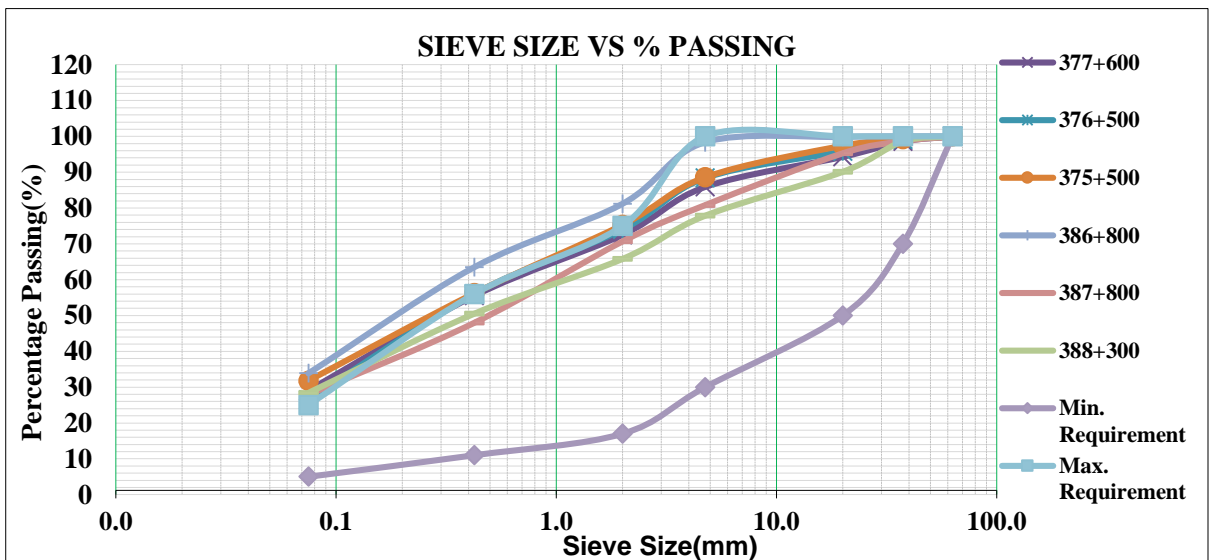
Figure 4-8 Sieve analyses results of sub base material
