GEOTECHNICAL INVESTIGATION ON CAUSES OF ROAD FAILURE OF
DODOLA –GOBA ASPHALT ROAD PROJECT AND THEIR REMEDIAL
MEASURES

JUNE, 2022

A THESIS SUBMITTED TO THE DEPARTMENT OF CIVIL ENGINEERING,
FACULTY OF CIVIL ENGINEERING AND BUILT ENVIRONMENT, SCHOOL OF
GRADUATE STUDIES HAWASSA UNIVERSITY.

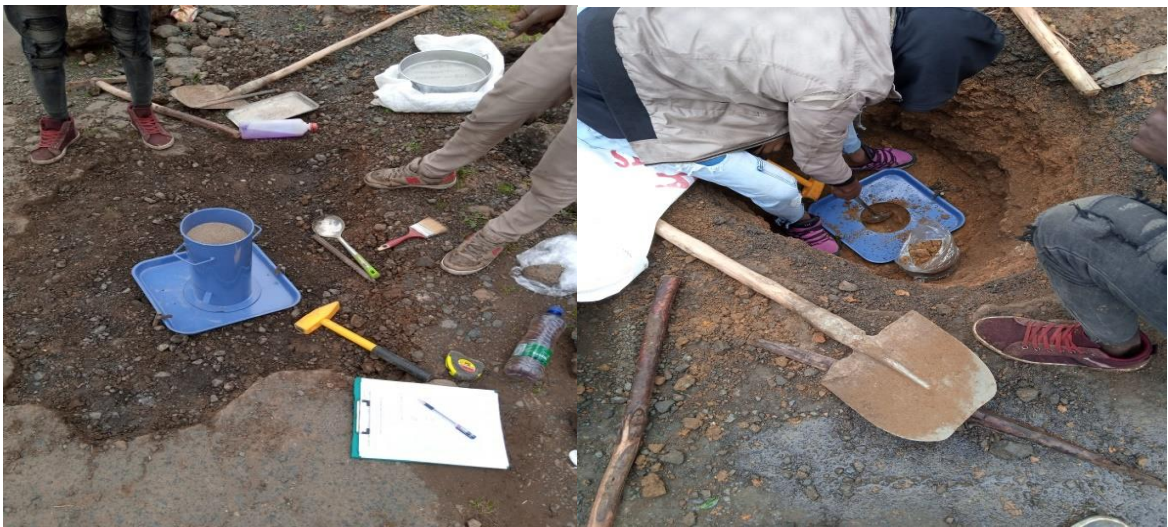
Figure 3-2 Field density determination and thickness measurements.

Selected test pit locations were striped by using asphalt cutter and retrieving samples from each layer for the determination of field density test was made at each selected test pit stations for each layer of the road using Sand Replacement Method by AASHTO T-191 and sample taken for in situ moisture content covered by plastic and placed at the internal part of each disturbed samples within the sample bugs as shown on fig 3.2.
